## Full-scale load tests of Pearl-Chain arches

*Published in:*  
Engineering Structures

# Full-Scale Load Tests of Pearl-Chain Arches

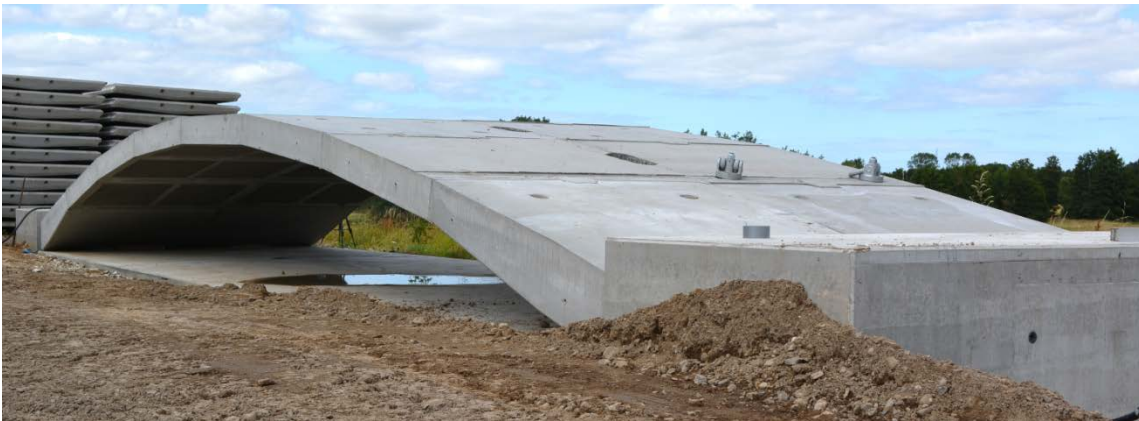
Figure 2: Two adjacent PC-Arches after assembly and lifting.

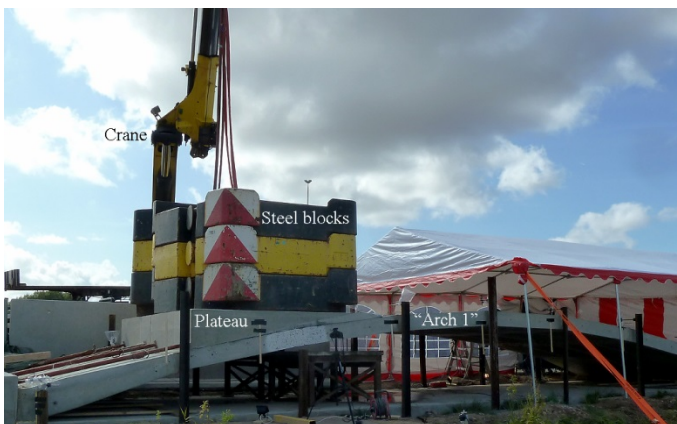
The bridge assembly was tested with two separate phases, with different investigative objectives for each test. In Test 1, deflections and strains were measured during loading to 66 tonnes (648 kN), when the test was stopped for safety reasons. This first test gave evidence for the transfer of forces through the Hammerhead joints, and permitted the study of the distribution of strains within an SL-Deck. Test 2, on the other hand, was conducted in order to determine the specimen's ultimate load capacity, and to observe its collapse mechanism. Figure 11 shows a photograph taken during Test 1.

Figure 11: Test 1. Six steel blocks, each weighing 10 tonnes, were set on the plateaus on “arch 1” (near side in photograph) and “arch 2”.
